# Intel<sup>®</sup> Pentium<sup>®</sup> III Processor Specification Update

Release Date: July 2001

Order Number: 244453-032

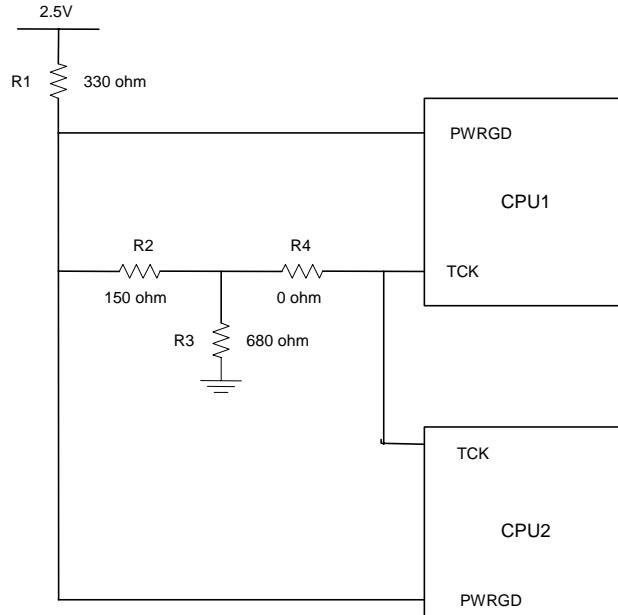
Pentium® III Processor with 512KB L2 Cache Platforms Workaround

Assumes the inputs to the CPU\_PWRGD are open collector signals that are Wire-ANDed together

- The example workaround circuit assumes that the PWRGD inputs into the processors are open collector. Tying the PWRGD inputs together in a Wired-AND fashion allows each processor to receive PWRGD at the same time but at the latter of the 2 separate PWRGD assertions. If separation of the PWRGD inputs to each processor is required, extra circuitry will be required.
